REPORT NO. NADC-76322-30

DETERMINATION OF THE AIRWORTHINESS OF ZPG-3W COTTON D-621
AND THE ZPG-2 DACRON GDC-5 AIRSHIP ENVELOPES

31 JANUARY 1977

FINAL REPORT

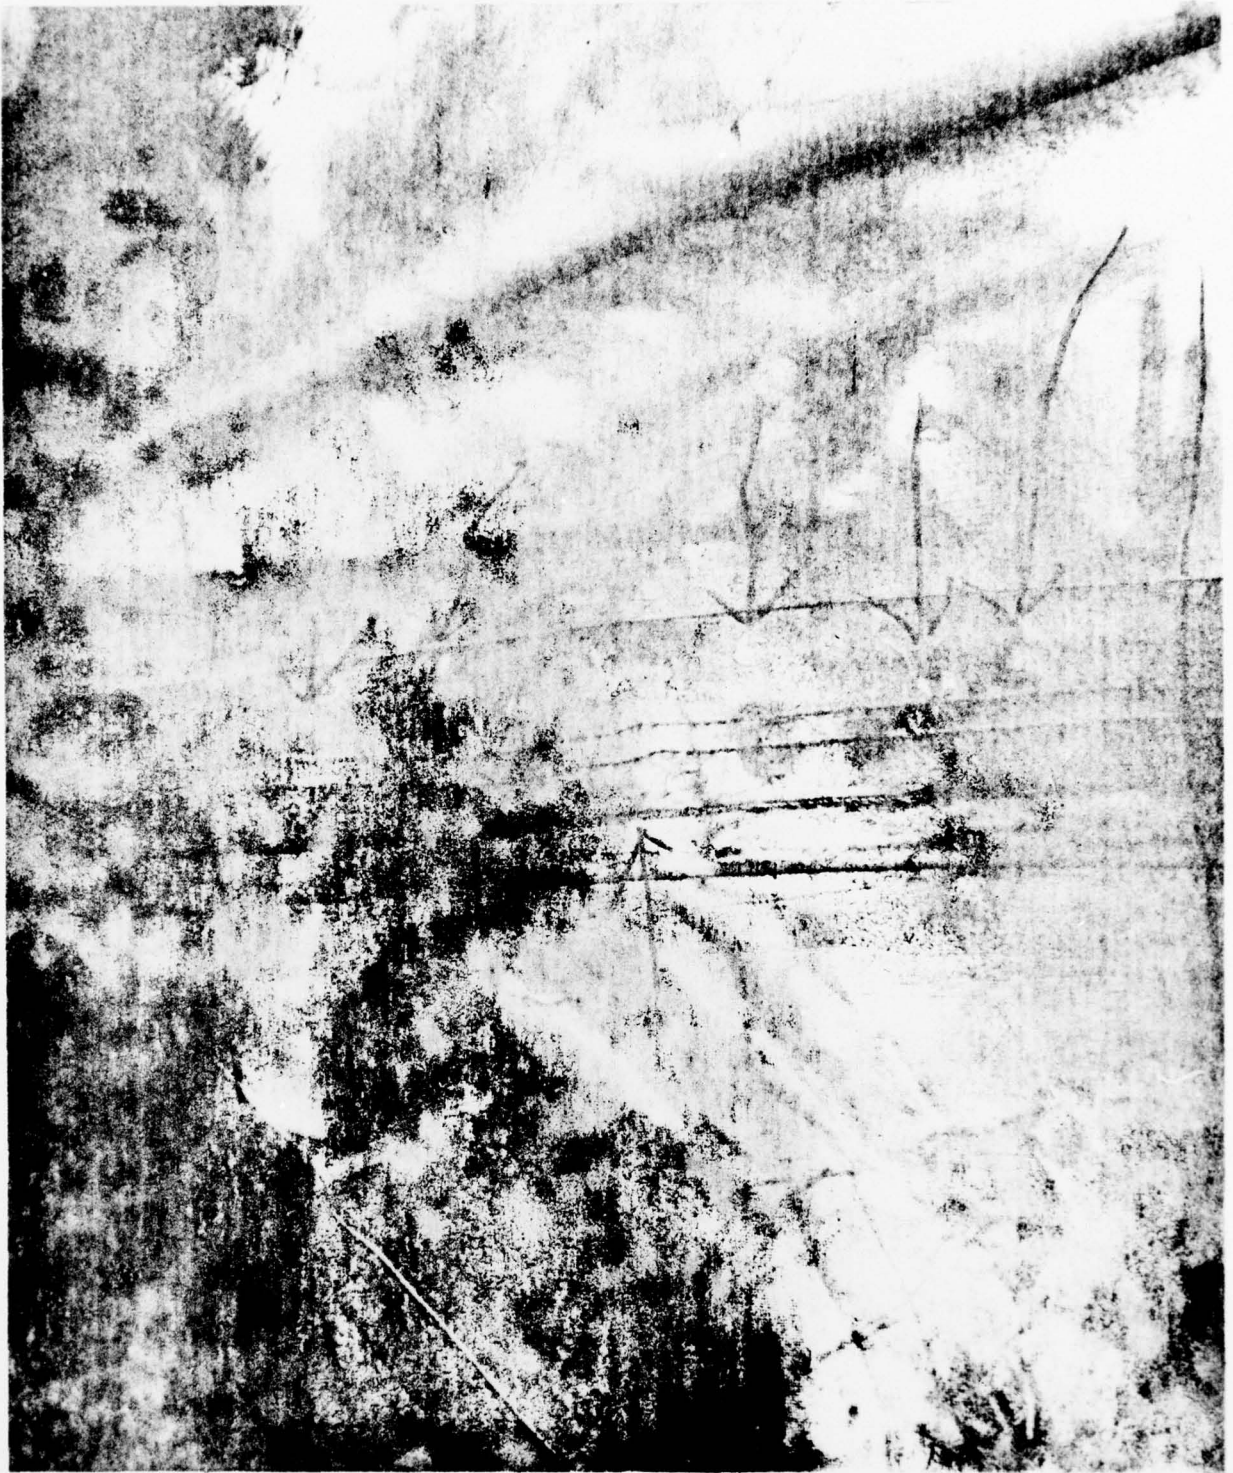
In general, the surface of the fabric had a good silver color and appeared to be that of a new fabric. Areas in the top center and the aft and forward ends were, however, discolored and contained a yellowish-green surface deposit. In these same areas, blisters under the tapes were observed and some had trapped water inside, Figure 1. The presence of trapped water was verified in that water spurted out of blisters when pierced with a knife point. During the time the envelope was on the deck, many of the blisters dried. Dried blisters are also seen in Figure 1.

Figure 1. Water Blisters Present under a Taped Seam in the
ZPG-2W Dacron Envelope, GDC-5

It was recommended by the inspection team that the areas of the ZPG-2 Dacron envelope GDC-5 exhibiting low ply adhesion be reinforced or replaced. The exact method of repair should be determined prior to actual commitment to use. The loading conditions and stresses should not exceed design values.

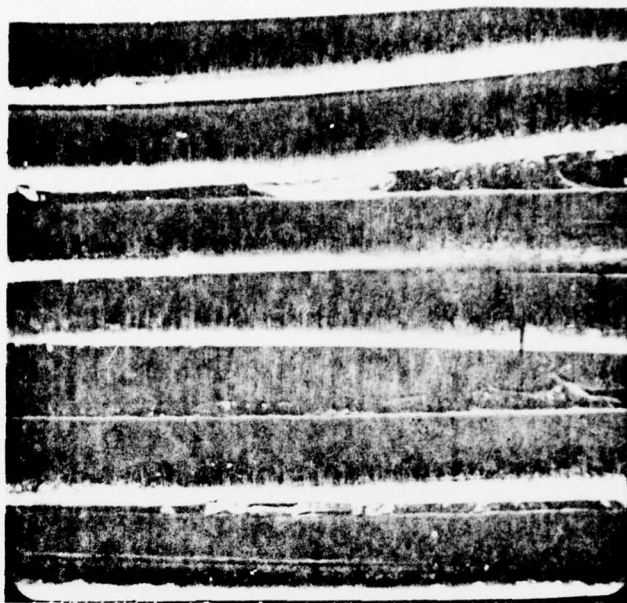
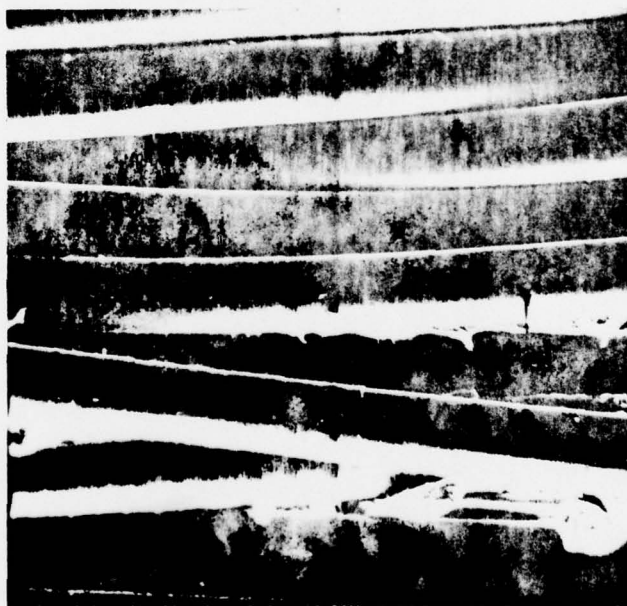
Figure 2. Photomicrographs of Specimens from the ZPG-2
Dacron Envelope GDC-5, (552X)

An electron microscopy examination was made by the Range Measurement Laboratory. The photomicrographs, Figure 2, show that the neoprene pulled off the polyester monofilaments of the better ply adhesion test specimens with difficulty, leaving pull marks (irregular mottled spots). These pulled marks are raised deformations caused by tension. No such pull marks appear on the monofilaments of test specimens with low ply adhesion.

The Range Measurement Laboratory, reference (h), hypothesized that the poor adhesion was caused by hydrolytic deterioration of the surface of the polyester yarns monofilaments. The electron photomicrographs do not verify that the weak adhesion of the neoprene interply is the result of such hydrolytic decomposition. The photomicrographs, however, do show that the neoprene pulled off the areas of good ply adhesion with difficulty leaving "pull marks" evidenced by the irregular mottled spots. Tension between the plies probably caused these deformations. In contrast, the specimens with poor ply adhesion did not show any "pull marks" but the surface of the polyester monofilaments were smooth.

Specimen from Sample Disc with Good Ply Adhesion

Specimen from Samples Disc with Low Ply Adhesion
